Fremantle Ports Inner Harbour Maintenance Dredging

Dredging Environmental Management Plan Compliance Report - 2025

REPORT NUMBER: R250272 / 25ENV451

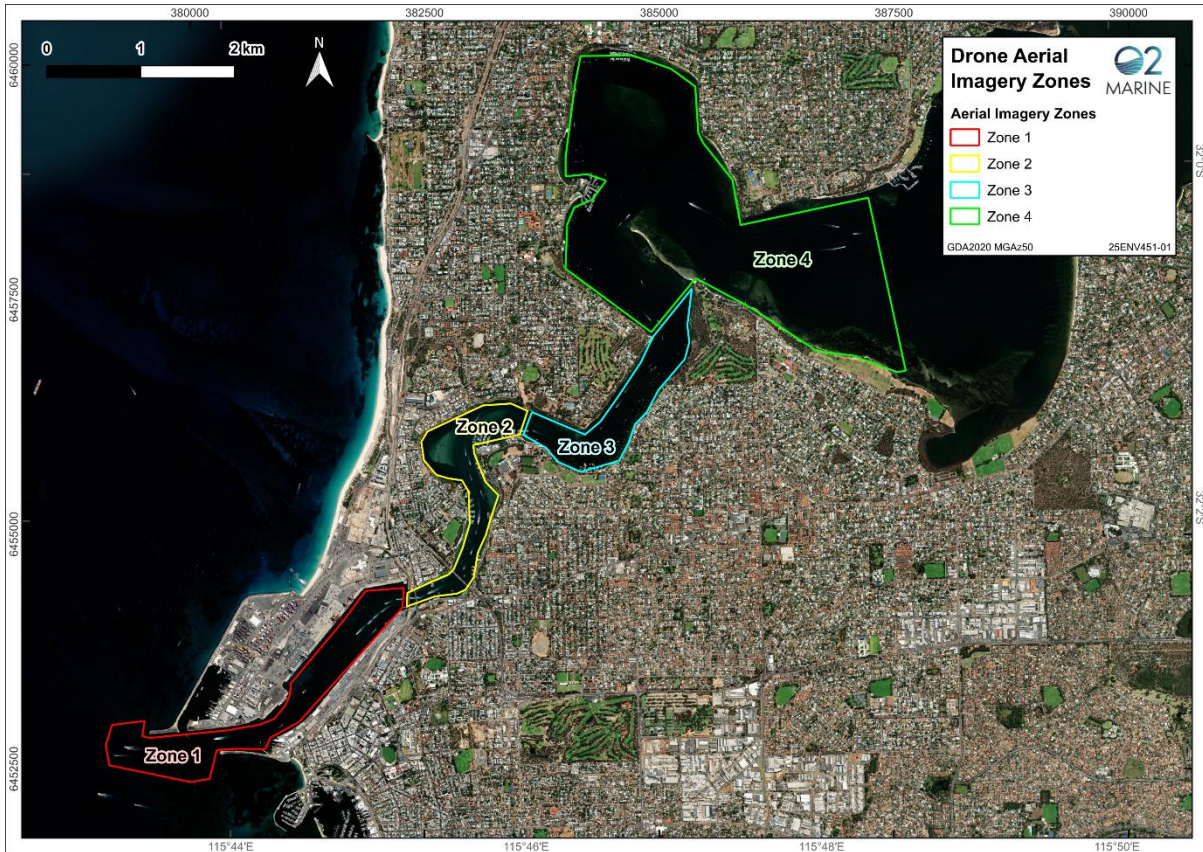
Figure 3: Drone aerial imagery Zones

A Civil Aviation Safety Authority Pilot and Unmanned Aerial Vehicle operator surveyed four zones extending from the Entrance Channel up to Point Walter. A series of images were collected along this extent to allow validation of the visible surface plume. At each site, the drone was flown upstream and downstream to capture imagery over the full extent of the river. Where possible, images were taken as close to high tide as possible to capture the worst-case plume dispersion.

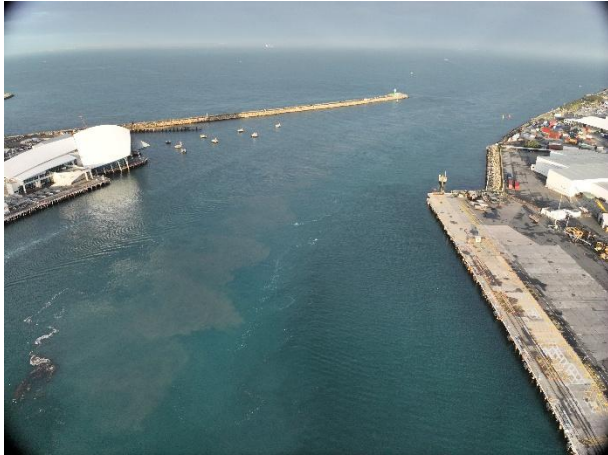
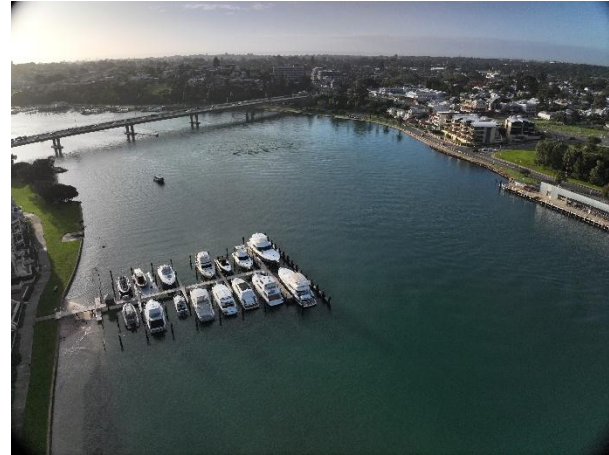
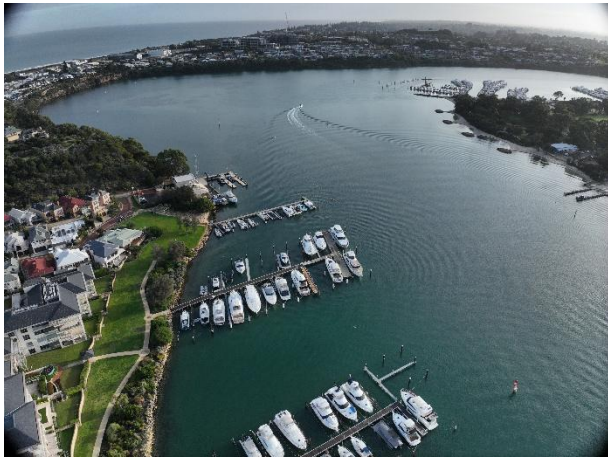
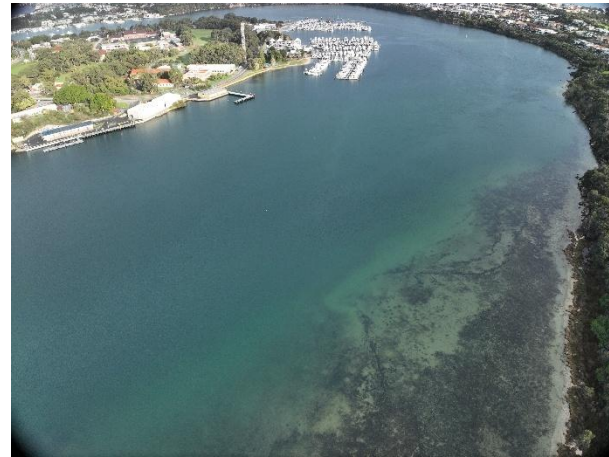
Figure 5: Drone aerial imagery from Day 2 – 24 June 2025

On day 2 of dredging, plumes were observed in the Inner Harbour (Appendix A, Figure 4, Zone 1) and extended to the Entrance Channel. The plumes appeared to be contributed by a large outbound vessel. No sediment plumes were observed in post dredge monitoring on 4 July (Appendix A, Figure 7, all Zones). Post dredge drone imagery was not collected on the 17 July as plumes were not observed during sampling on the 4 July, and exceedances reported on this occasion were considered to represent natural variability in weather conditions.

Imagery from both the RIUs and drone were used to aid in a visual assessment of water clarity. Images from Appendix A and Appendix B portray a visual plume on day 2 of dredging which appeared to be confined within the Inner Harbour and partially into the Entrance Channel. It was assumed that the plume was caused by a large outbound vessel rather than by dredging operations. Water clarity result and the images obtained during the last drone flight event (4 July) demonstrated improved water clarity
