BEST PRACTICE AND MARINE SAFETY CRITERIA BULLETIN 02-2022

BPMSCB 02-2022: Safety of Marine Pilot Transfer arrangements

Objective and area of focus - Marine Pilot Transfer arrangements and the transfer process:

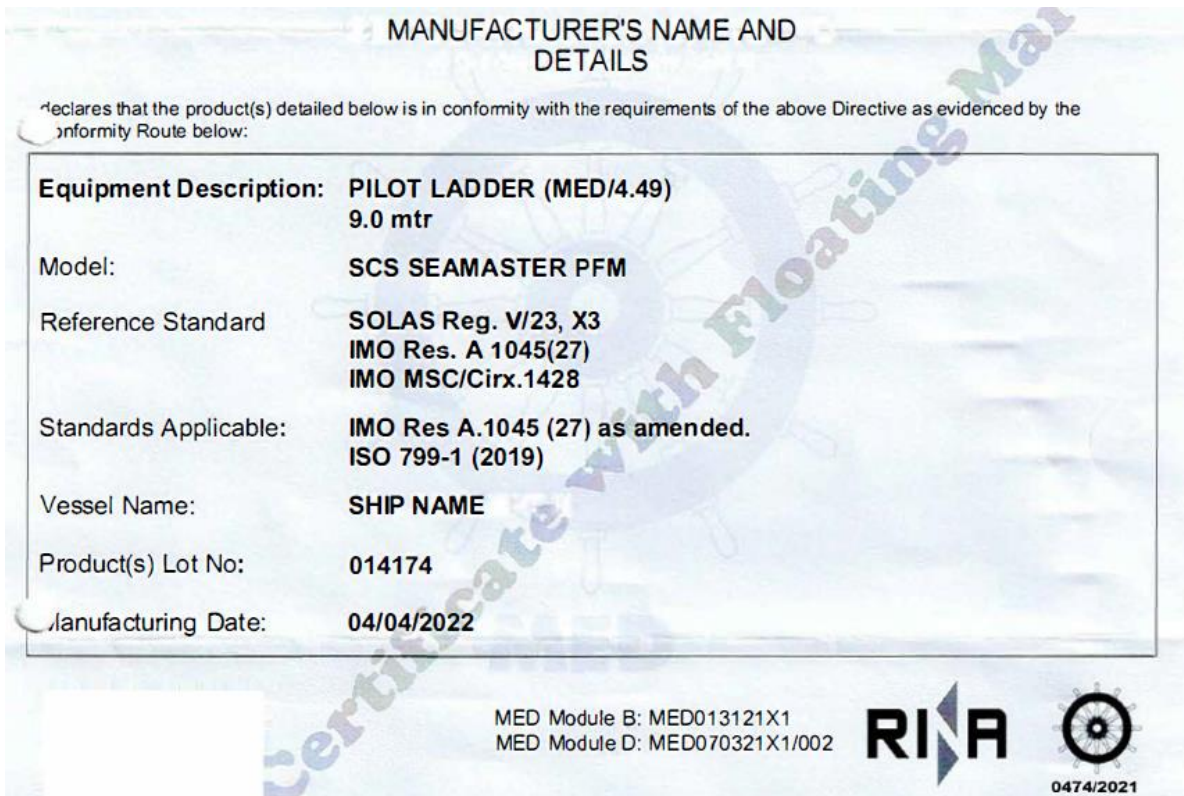
(Example of a compliant pilot ladder certificate)

Pilot ladders **MUST** be certified by the manufacturer / Classification Society as complying with requirements as mentioned under either IMO Resolution A.1045(27) or International Standard ISO 799-1:2019. **Proof of certification MUST be kept on board and produced when requested by Fremantle Ports'.**

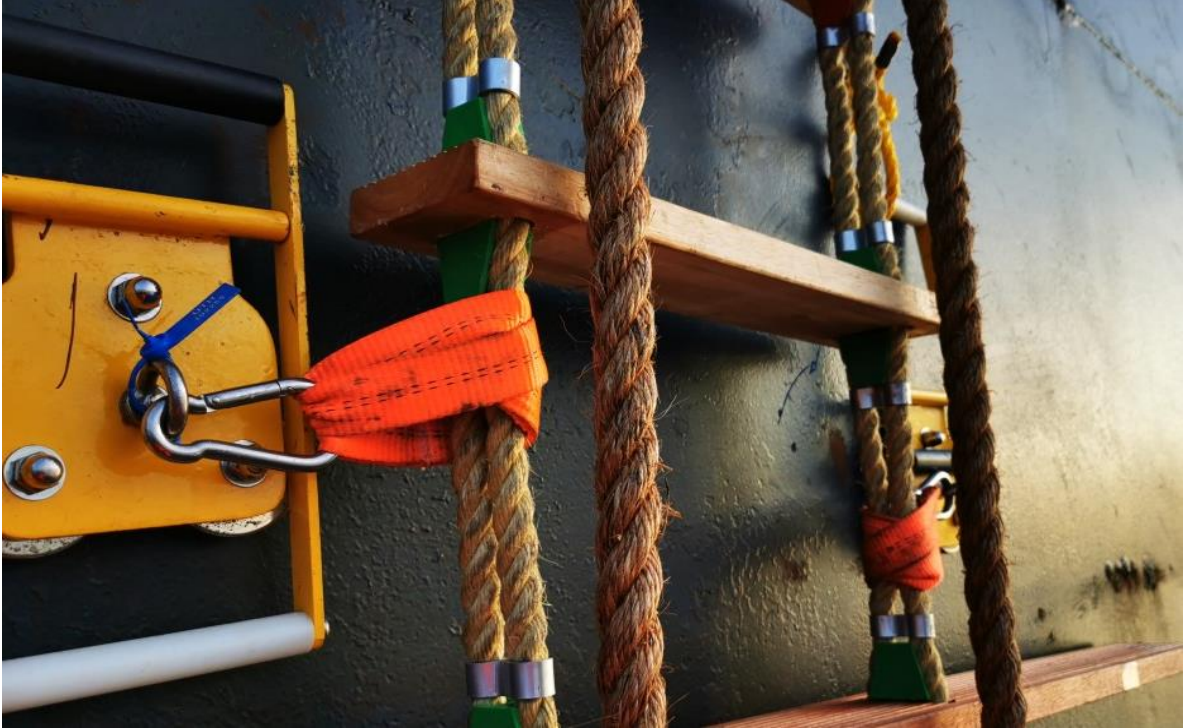
Each step of the pilot ladder **MUST** rest firmly against the ship's side. The pilot ladder **MUST** be secured to ship's side using eye pad or handhold or by a mechanical device such as magnetic clamps or a pneumatic suction pad.
